SIM 61 01 23

SERVICE ACTION: (12V) BATTERY BOX COVER REPLACEMENT

| E-Series | Model Description | Production Date |
|---|---|---|
| F56 | MINI Cooper SE Hardtop 2 Door Battery Electric Vehicle (BEV) | October 7, 2020 – April 1, 2021 |

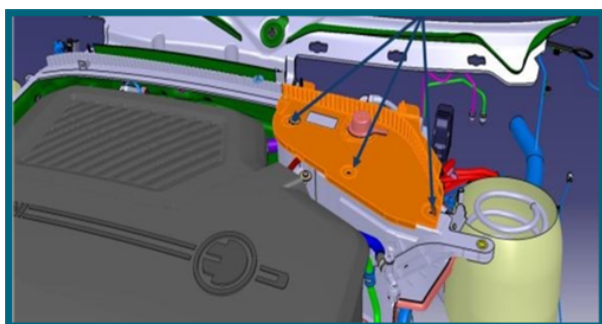
A. Remove the left cowl panel cover, please see repair instructions **REP 51 13 123 “Removing and installing/replacing left cowl panel cover”**.

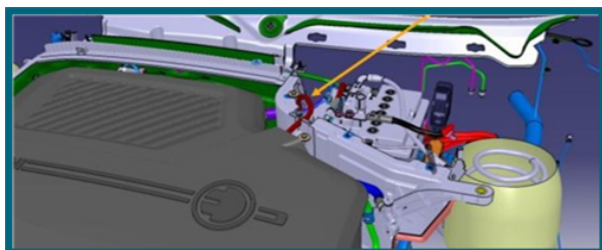
Oscillations in the electric drive can occur. As a result, the 12 V positive battery cable may rub against the battery box cover.

Replace the 12 V battery box cover.

B. Remove the battery box cover and dispose of it.
